Bladerider X8 – Trouble Shooting

Last Update - August 26, 2008

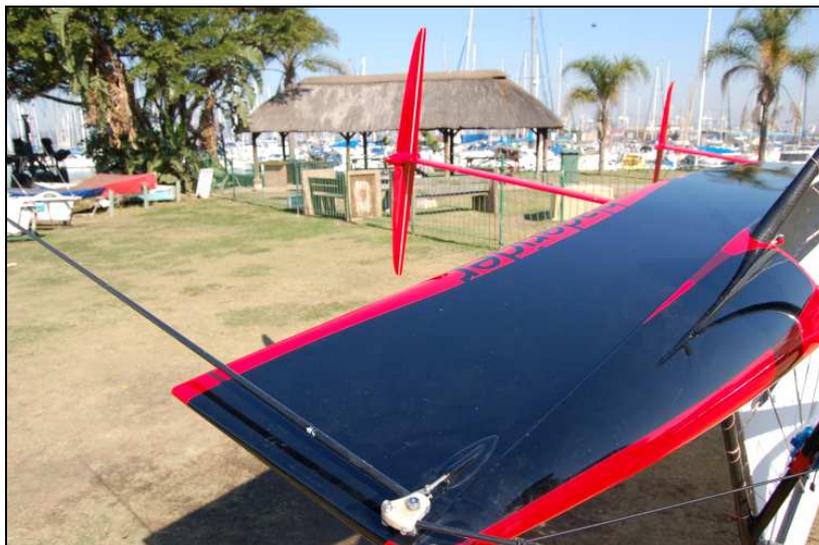
If there is little or no resistance in the wand linkages, then push the wand as far forward as possible. The wand should be perpendicular (or slightly forward of perpendicular) to the bow of the boat (as per photo below), and the flap should be in the 'fully up' position.

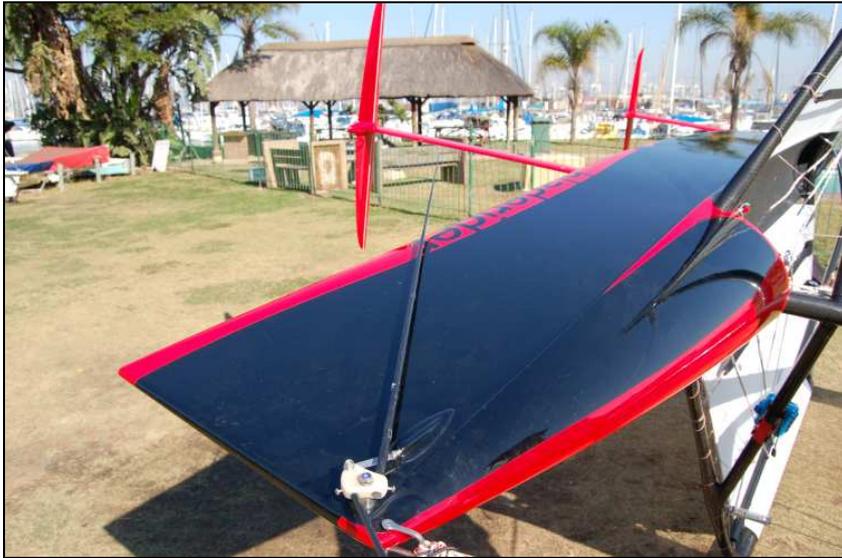
When the wand is pushed back as far as it can go (ie when the flap should be fully down), the wand should line up with the letters 'er' in the signage 'Bladerider' on the side of the hull (or be approximately 60 degrees to the bow as per photo below).

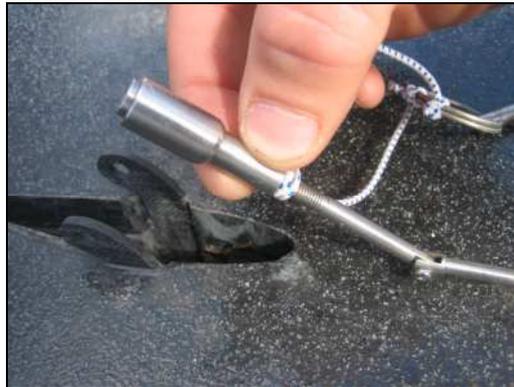
If the wand cannot be pushed back without force to the letters 'er' on the side of the hull (ie when the boat is sailed with the wand tip just under the waterline position), then there is probably too much lift on the front flap and boat will sail very high out of the water all the time. Therefore you will need screw in the socket joint head until you get the desired push-rod length and hence the correct amount of lift on the front foil flap (as per the photo below).

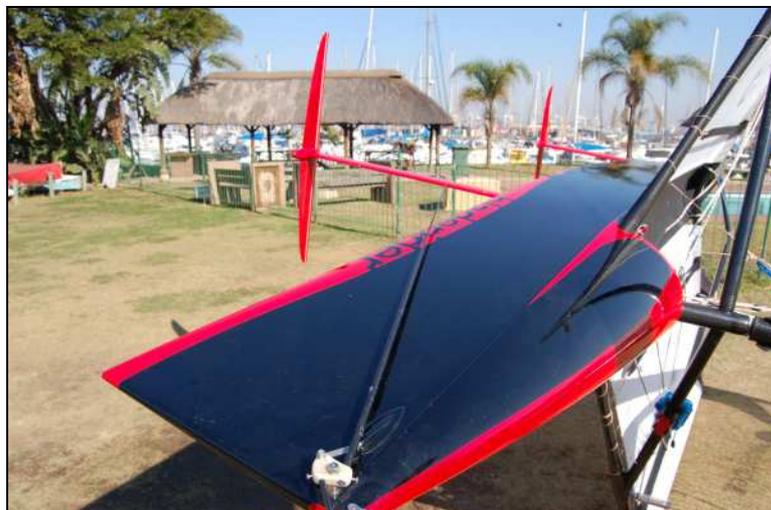
The first thing to check is if the wand can be pushed back passed the letters 'er' in the signage 'Bladerider' on the side of the hull (or be past 60 degrees to the bow as per photo below). If this is the case, then when the boat is sailing in displacement mode (low-riding and hoping to fly) with the wand at around 60-45 degrees to the bow, then the front flap is not pushed down enough and consequently does not give you enough lift to take off. Therefore you can fix this on water by simply winding out the ball/socket joint head at least two more turns at a time to give you more lift.

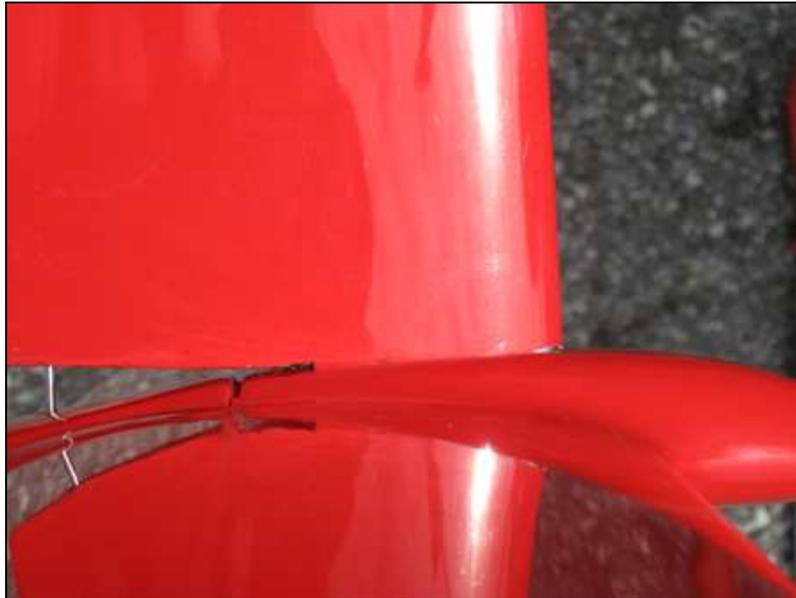
If this still does not fix the problem, then you will need check to see if the front foil is all the way onto the centerboard, as may not have been hit on hard enough when initially set up. To check this, there should only be a small 2mm gap between the back edge of the foil join and the bottom of the centerboard (as per the photo below). If not, remove the locking screw in the bottom and use a rubber mallet/hammer to hit the foil on further onto the bottom of the centerboard. Ensure that your strikes are directly forward and back of the hole on the bottom as so it works its way on slowly. This should be a very tight fit, so you may need to hit hard.

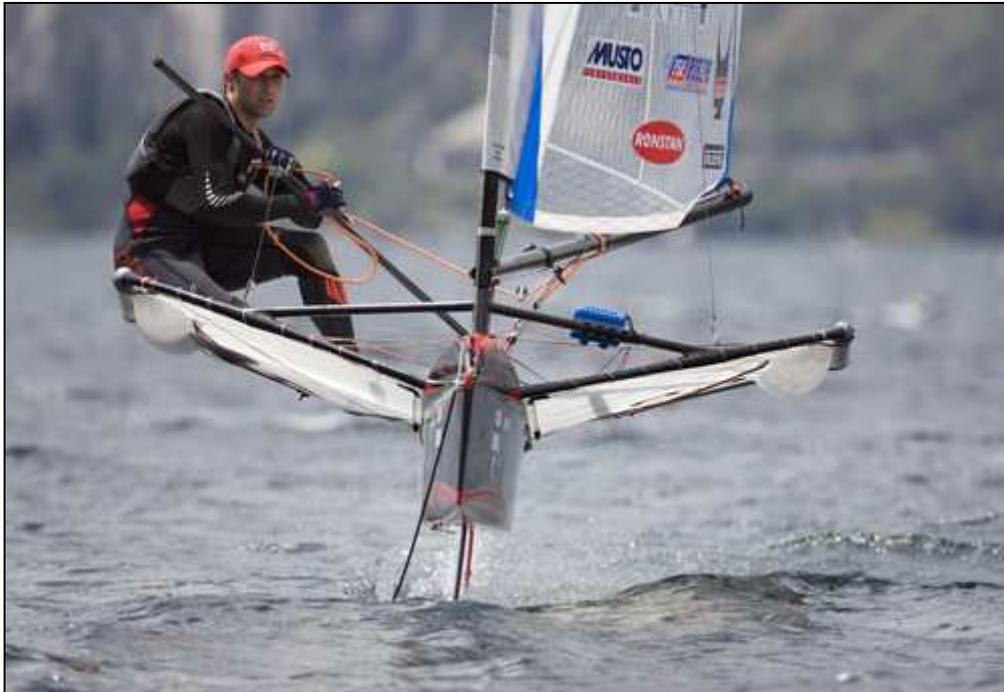
If your wand annoyingly taps on the side of the hull at low speeds or worse still the centerboard or rudder is cavitating or stalling (ie air bubbles and drag on the vertical sides of the blades), this is due to the wand not being offset enough from the centerline of the hull.

This is because the air bubbles that the wand creates under water in the centerline, can be sucked down by either the centerboard or rudder which causes the sudden cavitation. Even if the wand is slightly offset, it only takes a small wave or turning to starboard to cause the problem. The problem is also greatly enhanced, the colder the water gets.

If this does happen to you whilst sailing, it is suggested to keep the boat as close to the water as possible and avoid too high speeds until you can get back ashore. Then unscrew the wand and rotate it so that the wand will 'ski' and bend away from the centerline of the hull once under pressure (as per photo below).

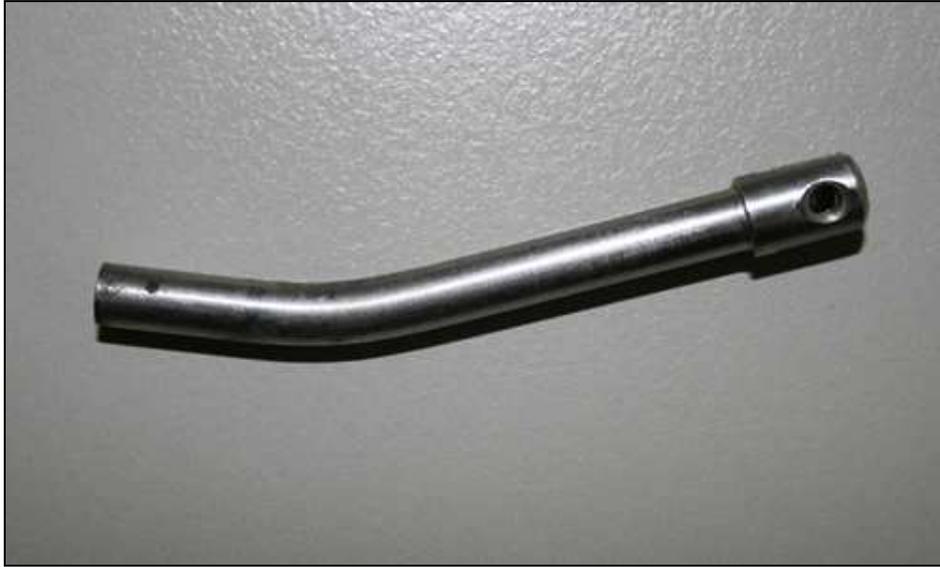
7.1.6 Front Push Rod Cable Slider comes out too far and bends

If your cable slider can pull too far out of the hull and on occasions, the slider has bent upwards, then firstly check that the amount of travel or the amount the push rod can slide back and forth is no more than 30mm. If it can travel more than this amount, it means that they can extend too far out of the hull and bend due to the exit hole in the cockpit or near the bow being too short. Therefore you will need to shorten the push rod inside the hull by an amount so that it cannot travel more than 30mm. A replacement hull push rod may not help as it will be same length as the one that you have already, however it is important that you first check that the cable sliders are wound all the way onto the push rod, otherwise if they are wound out, they will make the overall length longer and cause problems.

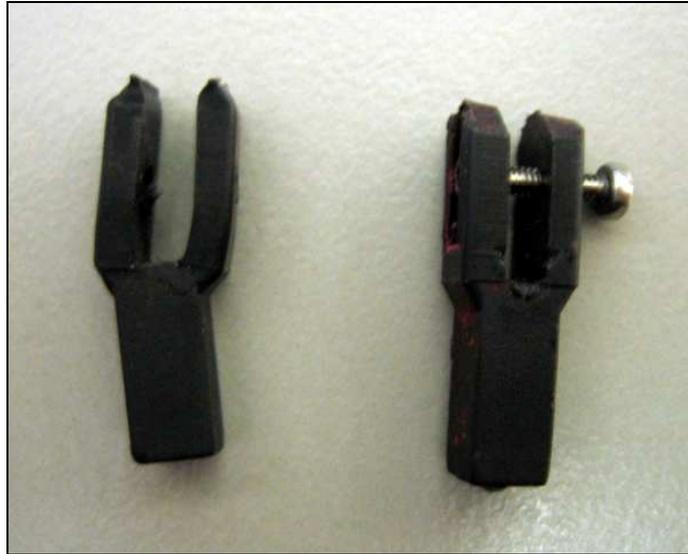
7.1.8 Upper Control Rod Connector is Deforming

Under a lot of load, the black plastic Upper Control Rod Connectors in the centerboard can deform, and give 'spring' in the push rod system. It is important to keep an eye on these, however you can make your own using some nylon 'chopping board' (or Teflon), a hacksaw, a 1.5mm drill bit and a 2mm tap. The idea is to cut a piece of nylon approx 25mm x 10mm x 7mm. Then cut an 8mm slot in the top to form the gate for the Bell Crank Axle. Then drill a 1.5mm straight hole in the top for the 2mm axle bolt, and another hole in the bottom for the push rod. Use a 2mm tap, to make the thread. See some home made examples below.

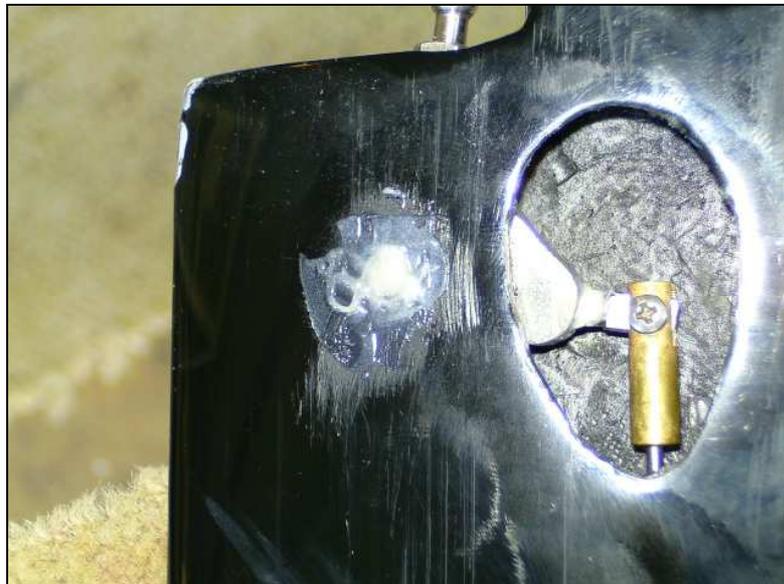
If the stainless steel axle at the top of the centerboard for the Bell Crank is unwinding itself when sailing or is loose inside the hole, then you will urgently need to glue in the axle on both sides to the centerboard, using ONLY epoxy glue with filler additive (only use 5 minute epoxy in emergencies).

Once the glue is set hard (after 24 hours), you will need to file/sand off any excess glue that will prevent the centerboard from being inserted into the centerboard case. There should no need to remove this axle in the future once your setup is correct, however it will be possible to cut it out if necessary.

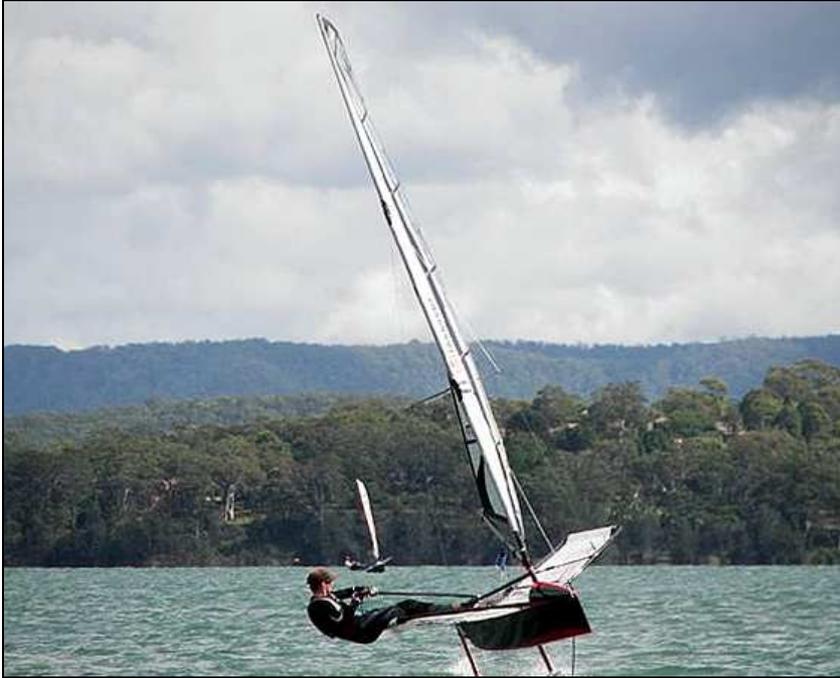
When sailing upwind in light/moderate conditions, the bow should only be angled about 1-3 degrees up and the wand should be angled approximately 30 degrees perpendicular to the bow so that the front foil flap is neutral for the best efficiency. In high winds, the hull should virtually be parallel to the water surface, and in order to do this, you may have to add lift onto the rudder foil to push the bow down and move forward to see the boat accelerate.
